# Manhole Inspection Summary

Manhole # S21WW1021MH

**Location** Address: **42 OLMSTED GREEN CT**

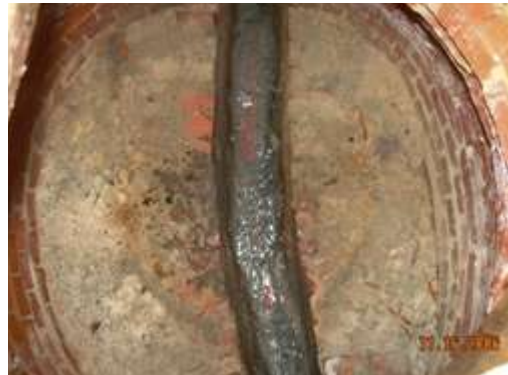
Top View

Bench debris.

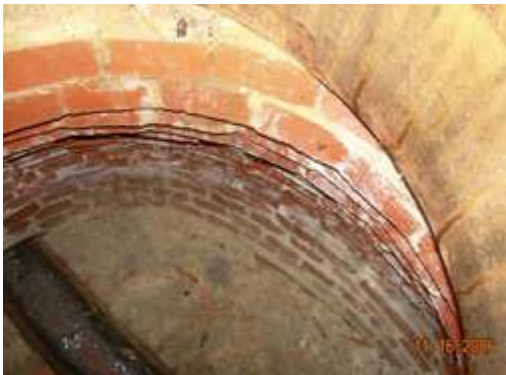
Defect 1

Infiltration: ☐ None ☒ **Joint** ☐ Cracks ☐ Mortar ☐ Roots ☐ Wall

Infiltration: ☐ None ☐ Joint ☐ Cracks ☒ **Mortar** ☐ Roots ☒ **Wall**

Frame leaks. Adjustment and Barrel infiltration.

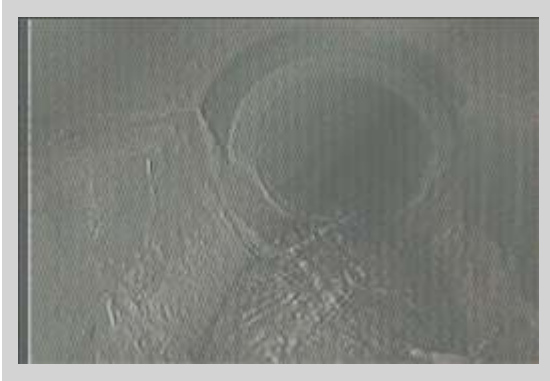
### 8 in. Circular Gravity Sewer Pipe Out @ 12 O'Clock

Infiltration: **Evidence** Pipe Seal Cond: **Unknown**

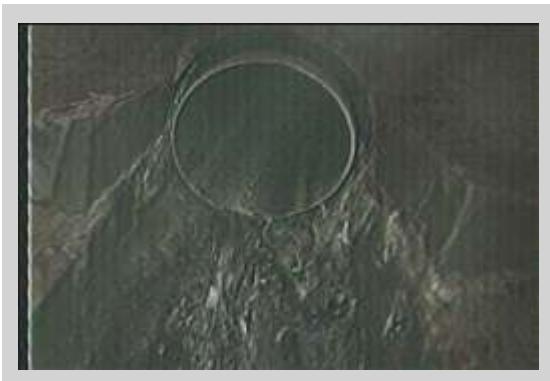
### 8 in. Circular Gravity Sewer Pipe In @ 6 O'Clock

Comments **The I6 pipe seal is not flush to the pipe.**
